Willow Lake Dam and Spillway Rehabilitation Project  
Sugarland Run HOA Board Meeting  
Wednesday, August 17<sup>th</sup>, 2022

# Willow Lake Existing Conditions and Deficiencies

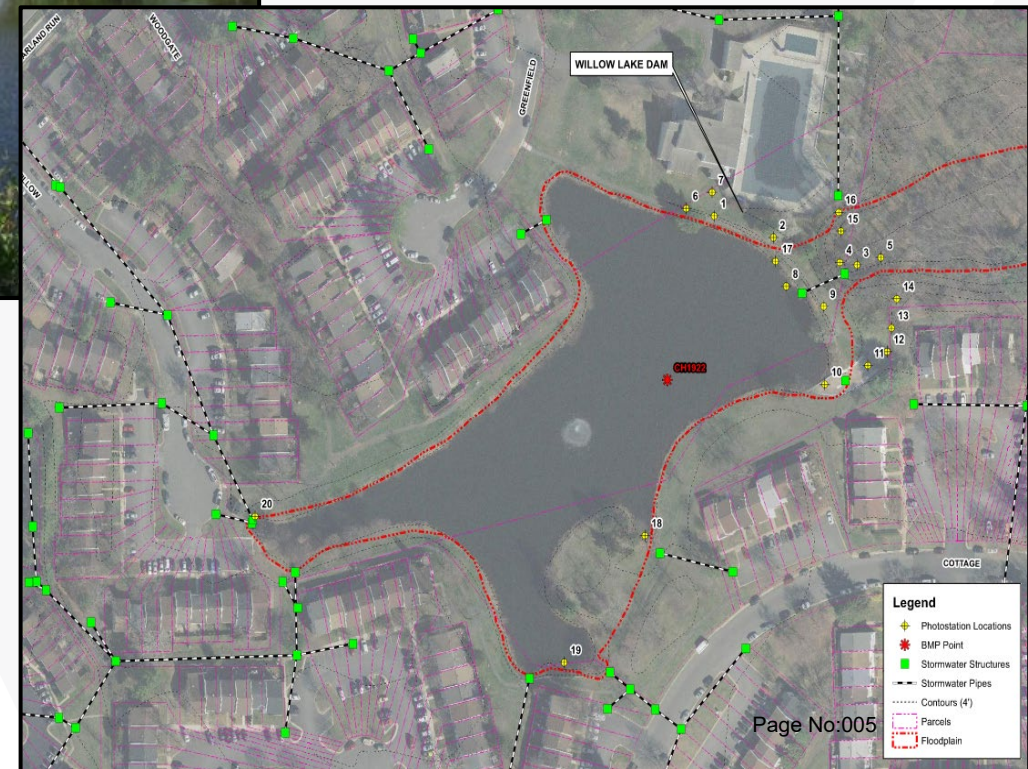
## What happened to the emergency spillway channel at Willow Lake?

- Based on in-field assessed conditions, sediment and debris stemming from the contributing urban drainage area to the pond, entered the riser structure, partially blocked the flow capacity of the principal spillway pipe (PSP) which caused a rise in normal pool water surface elevation. Because of this, the emergency spillway was enacted consistently with flow which caused the extreme downstream erosion.

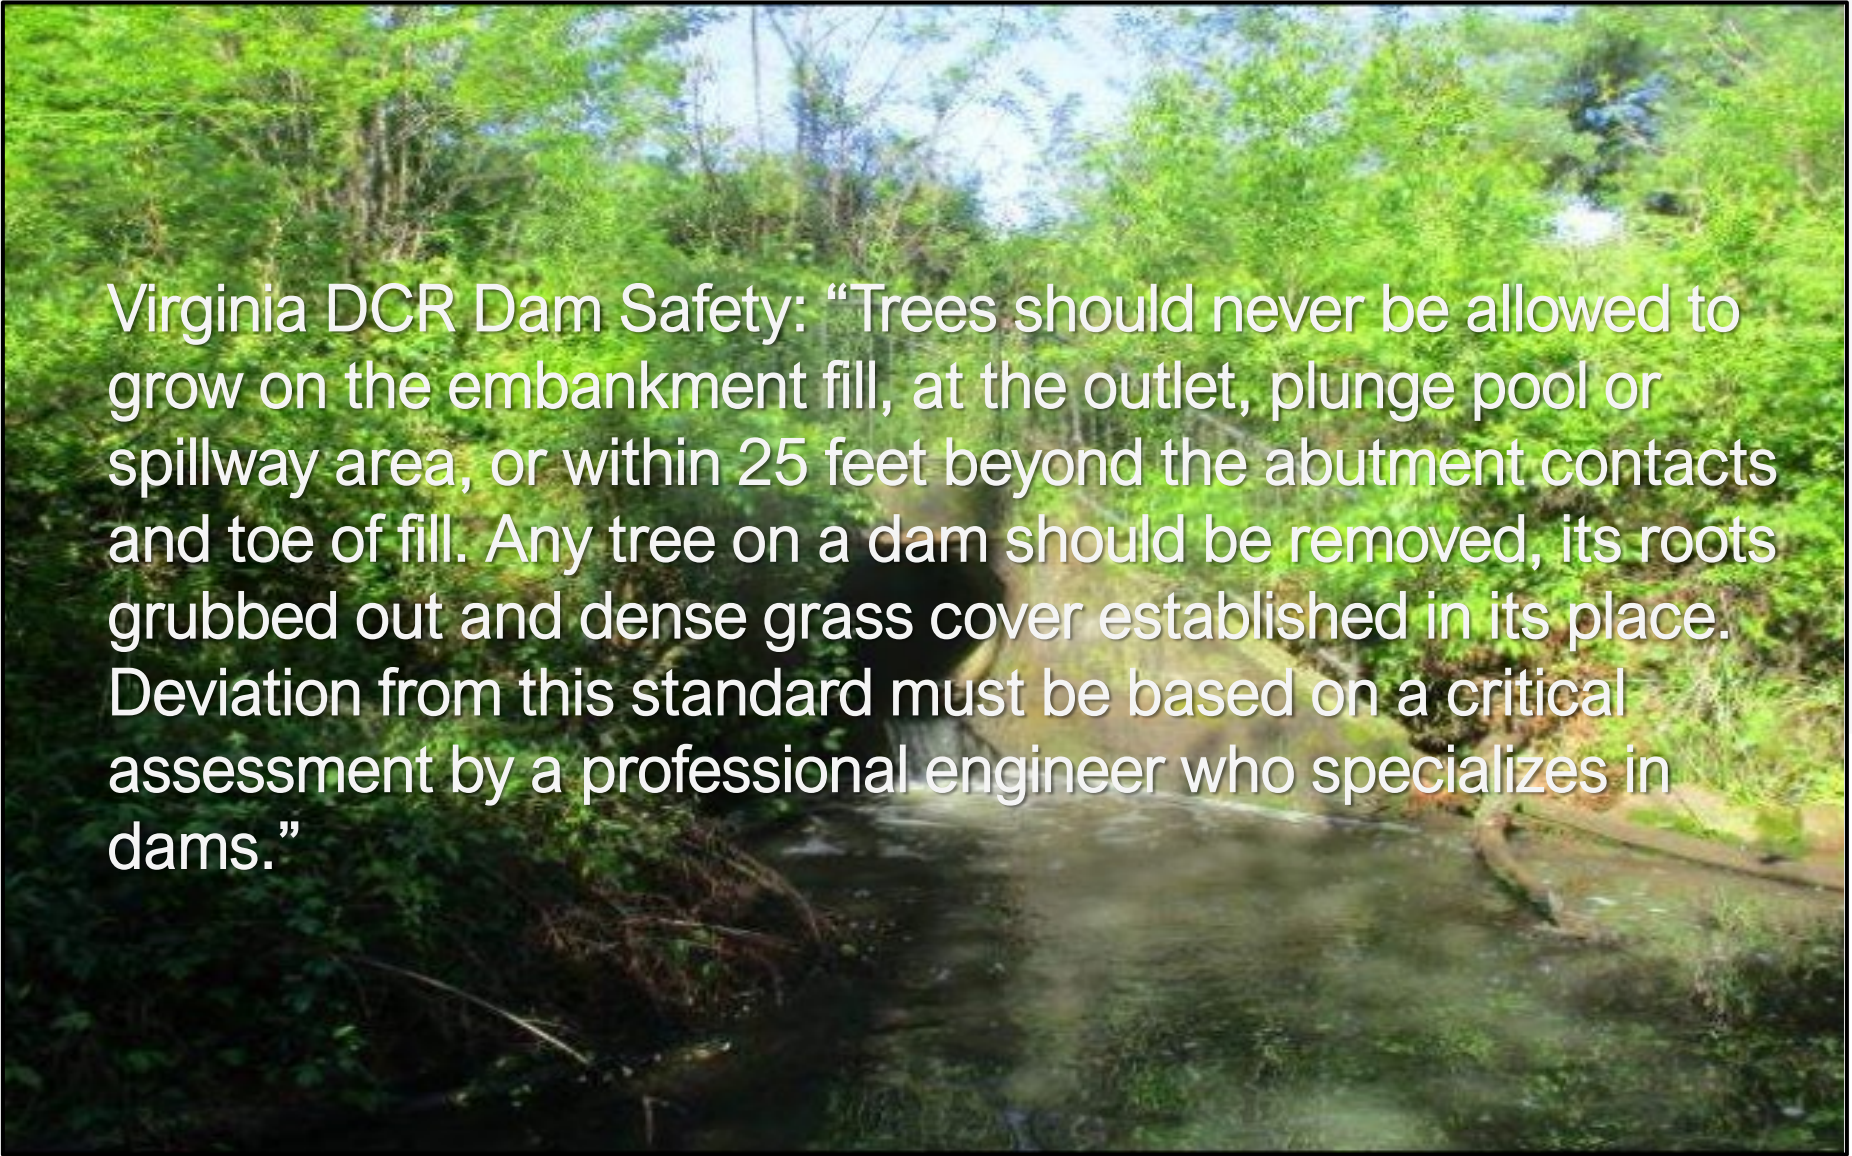
Virginia DCR Dam Safety: “Trees should never be allowed to grow on the embankment fill, at the outlet, plunge pool or spillway area, or within 25 feet beyond the abutment contacts and toe of fill. Any tree on a dam should be removed, its roots grubbed out and dense grass cover established in its place. Deviation from this standard must be based on a critical assessment by a professional engineer who specializes in dams.”

**Dam significantly overgrown with vegetation.**

**1** - Clearing, grubbing, and reseeding of all areas of the dam that are overgrown.

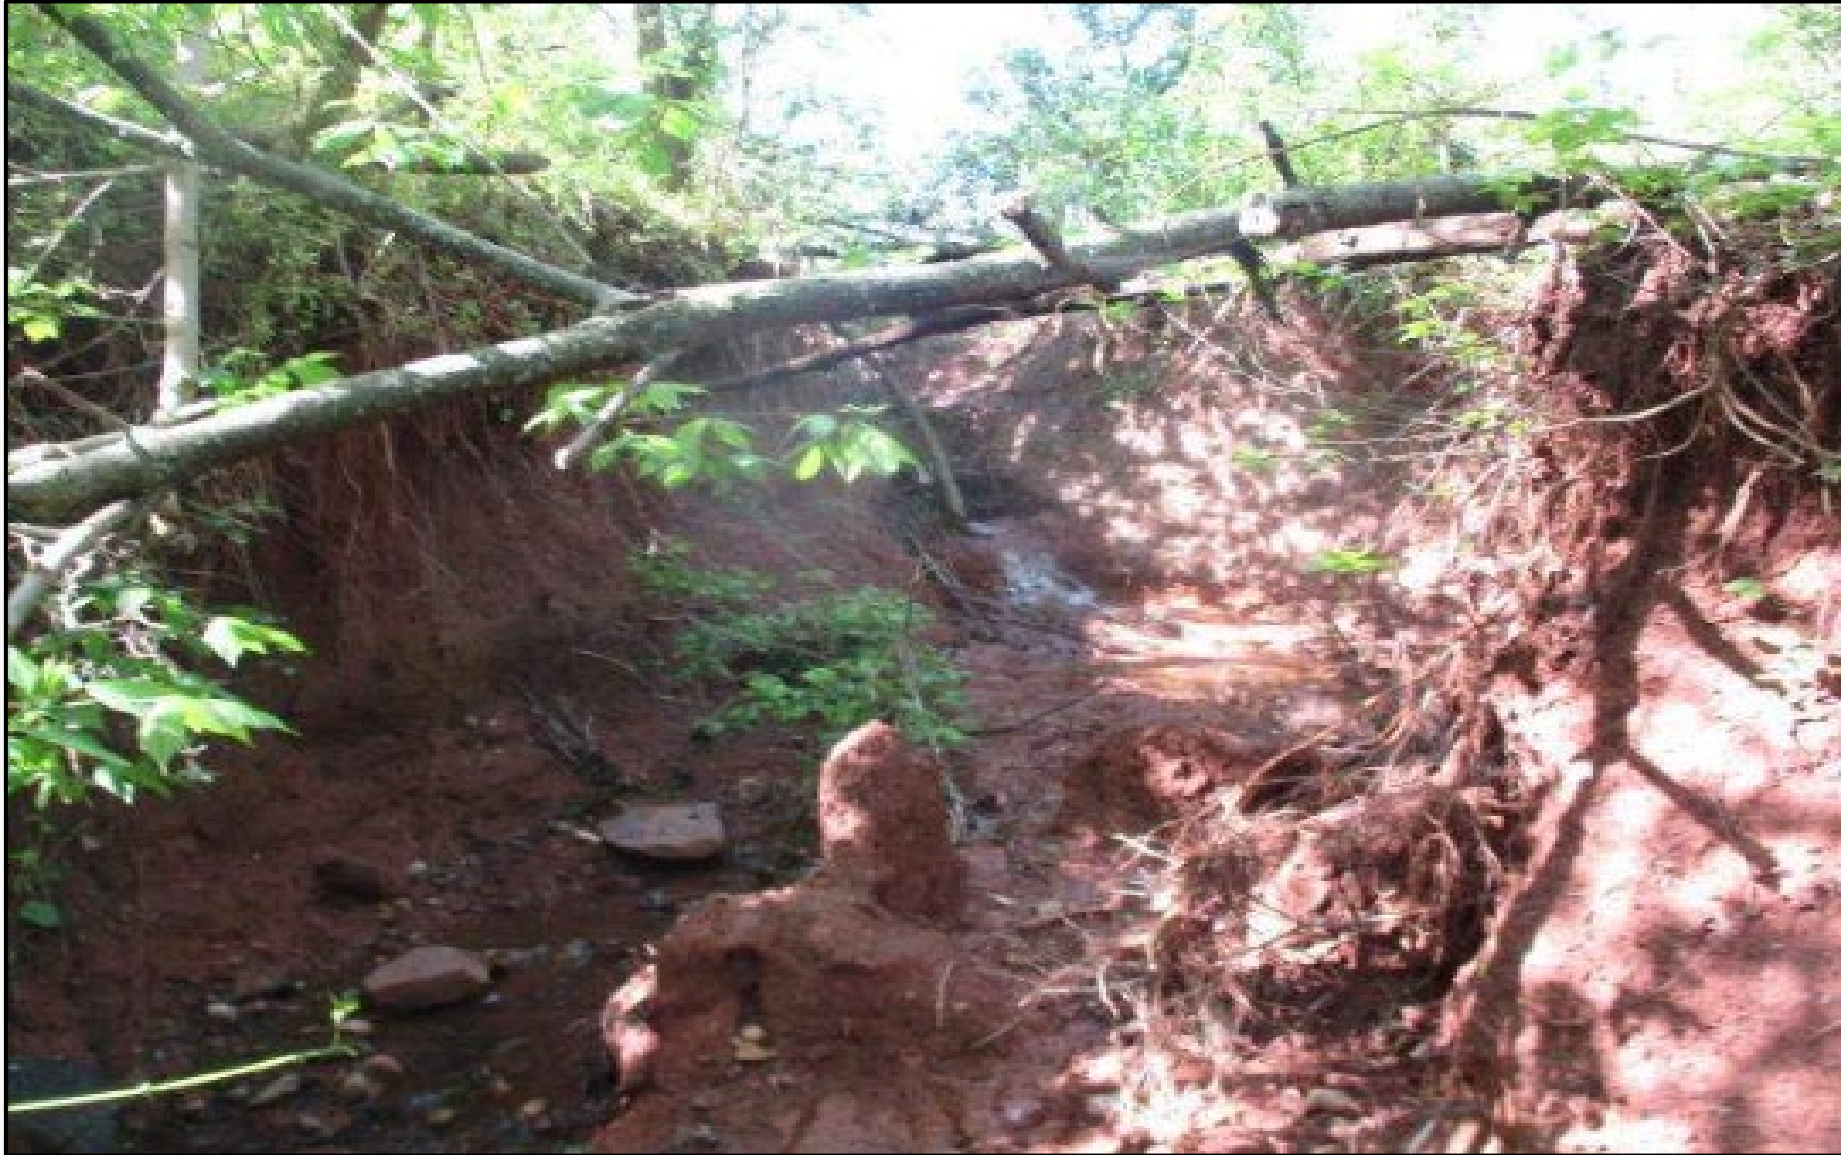
Significant erosion of the emergency spillway receiving channel.

**3** - Regrading/repair and armoring of the emergency spillway receiving channel, principal spillway pipe receiving channel, and storm sewer outfall receiving channel.

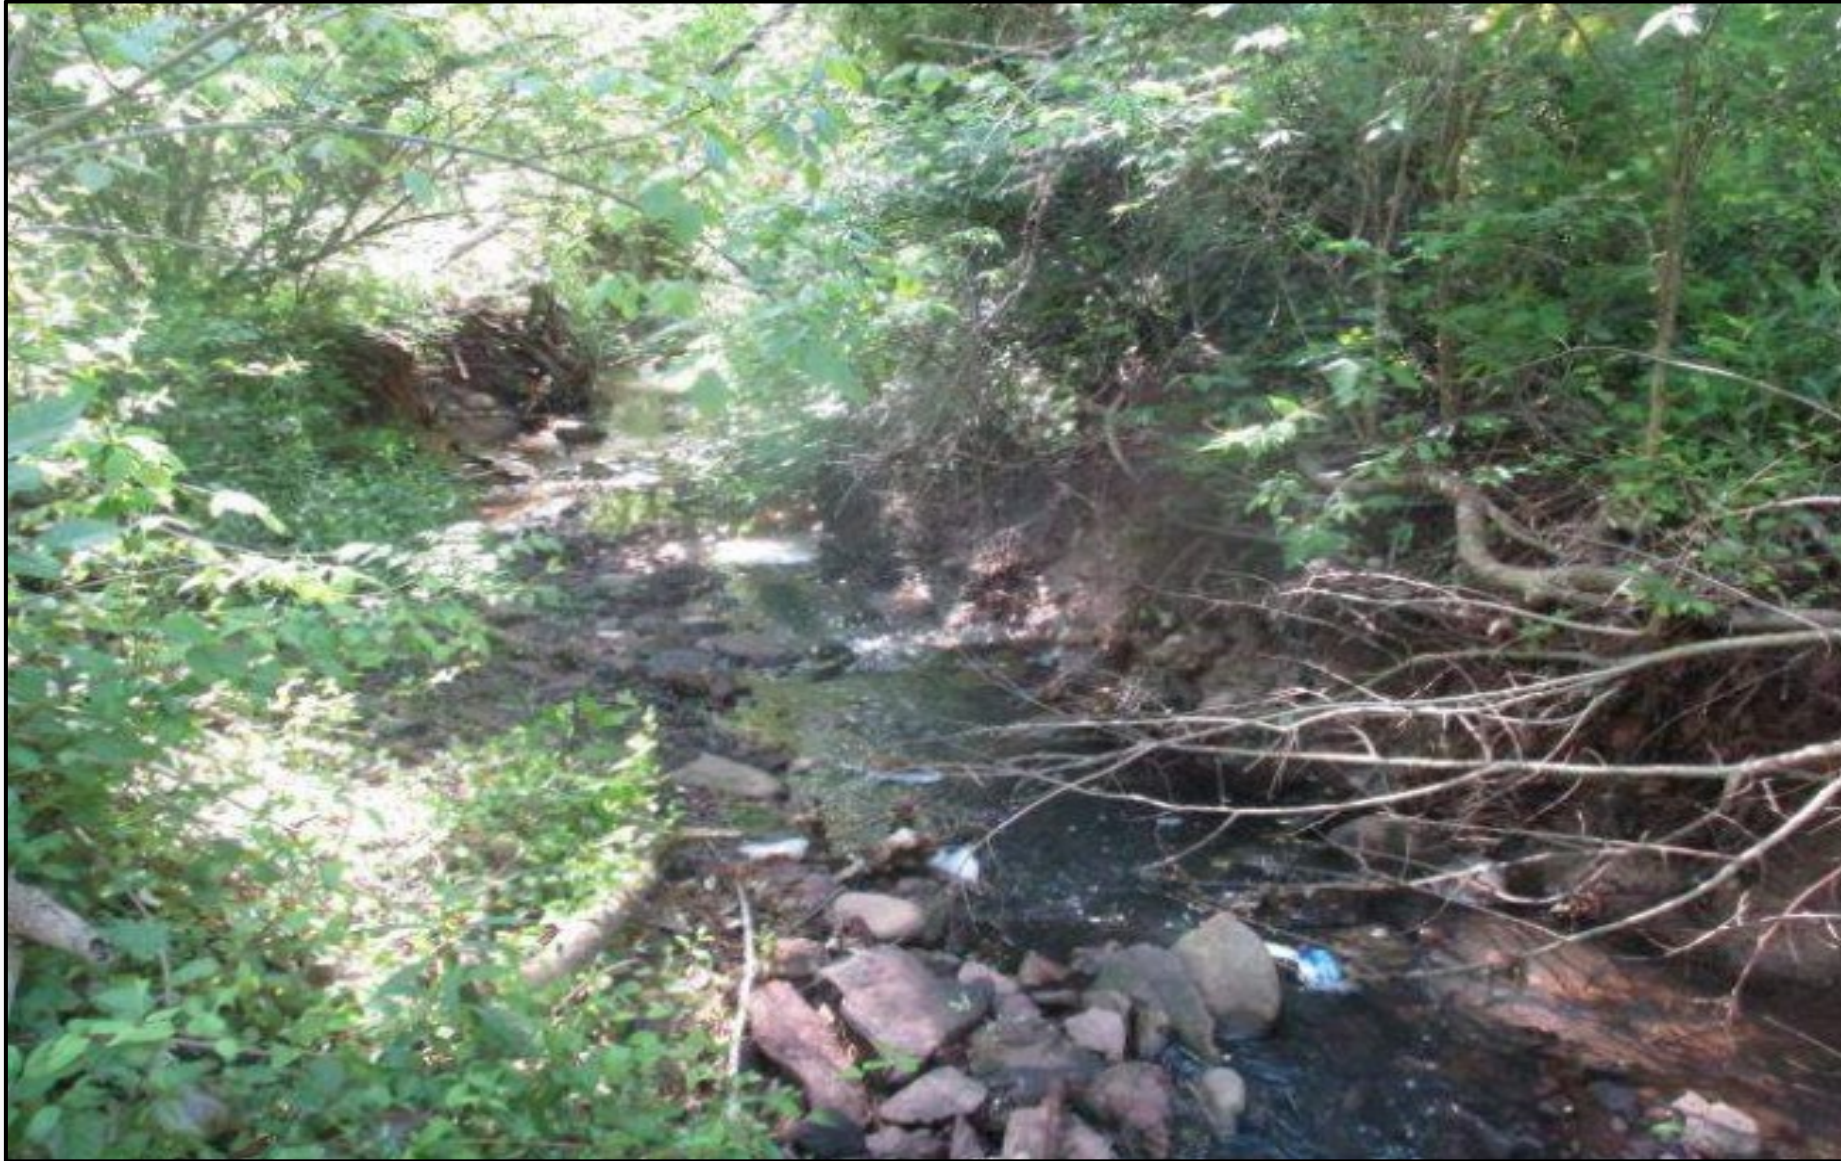
Significant erosion of the principal spillway receiving channel.

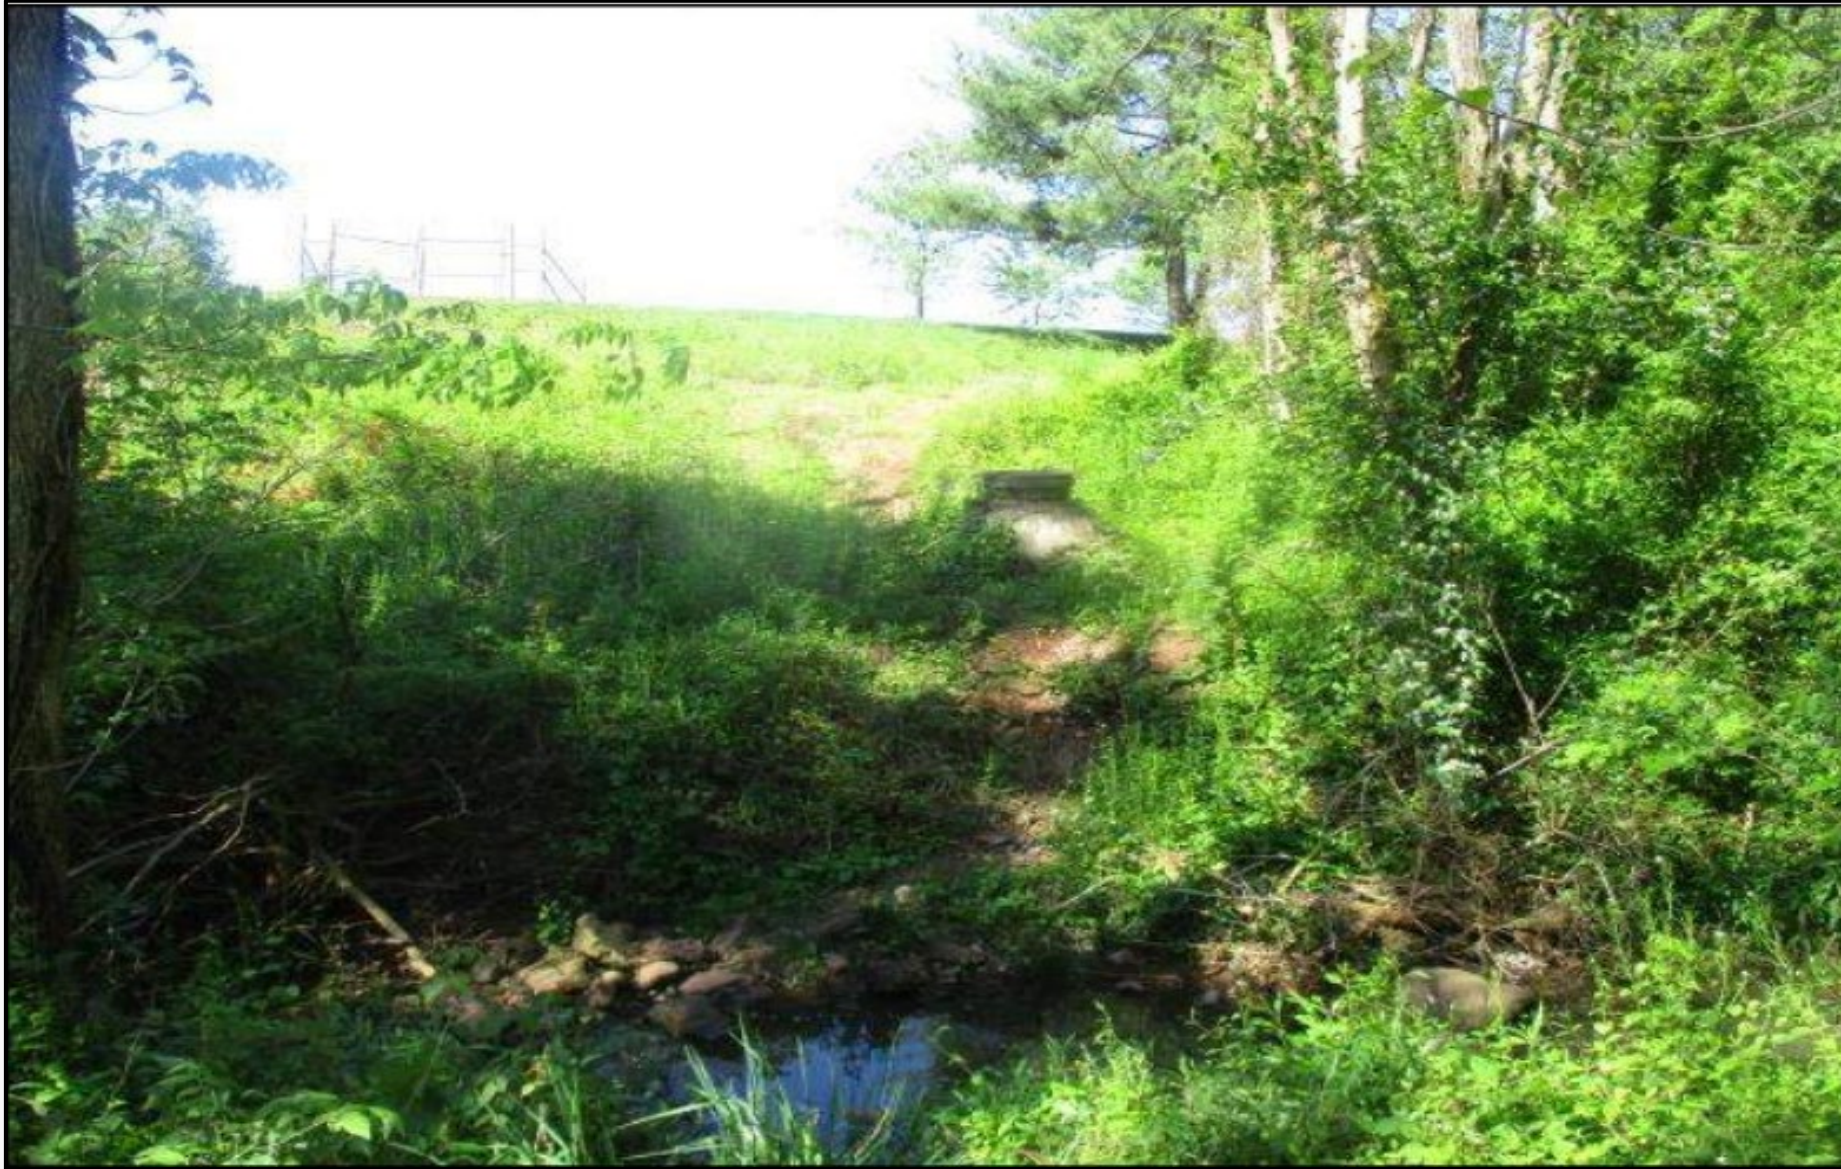
Toe of dam is undercut and eroding.

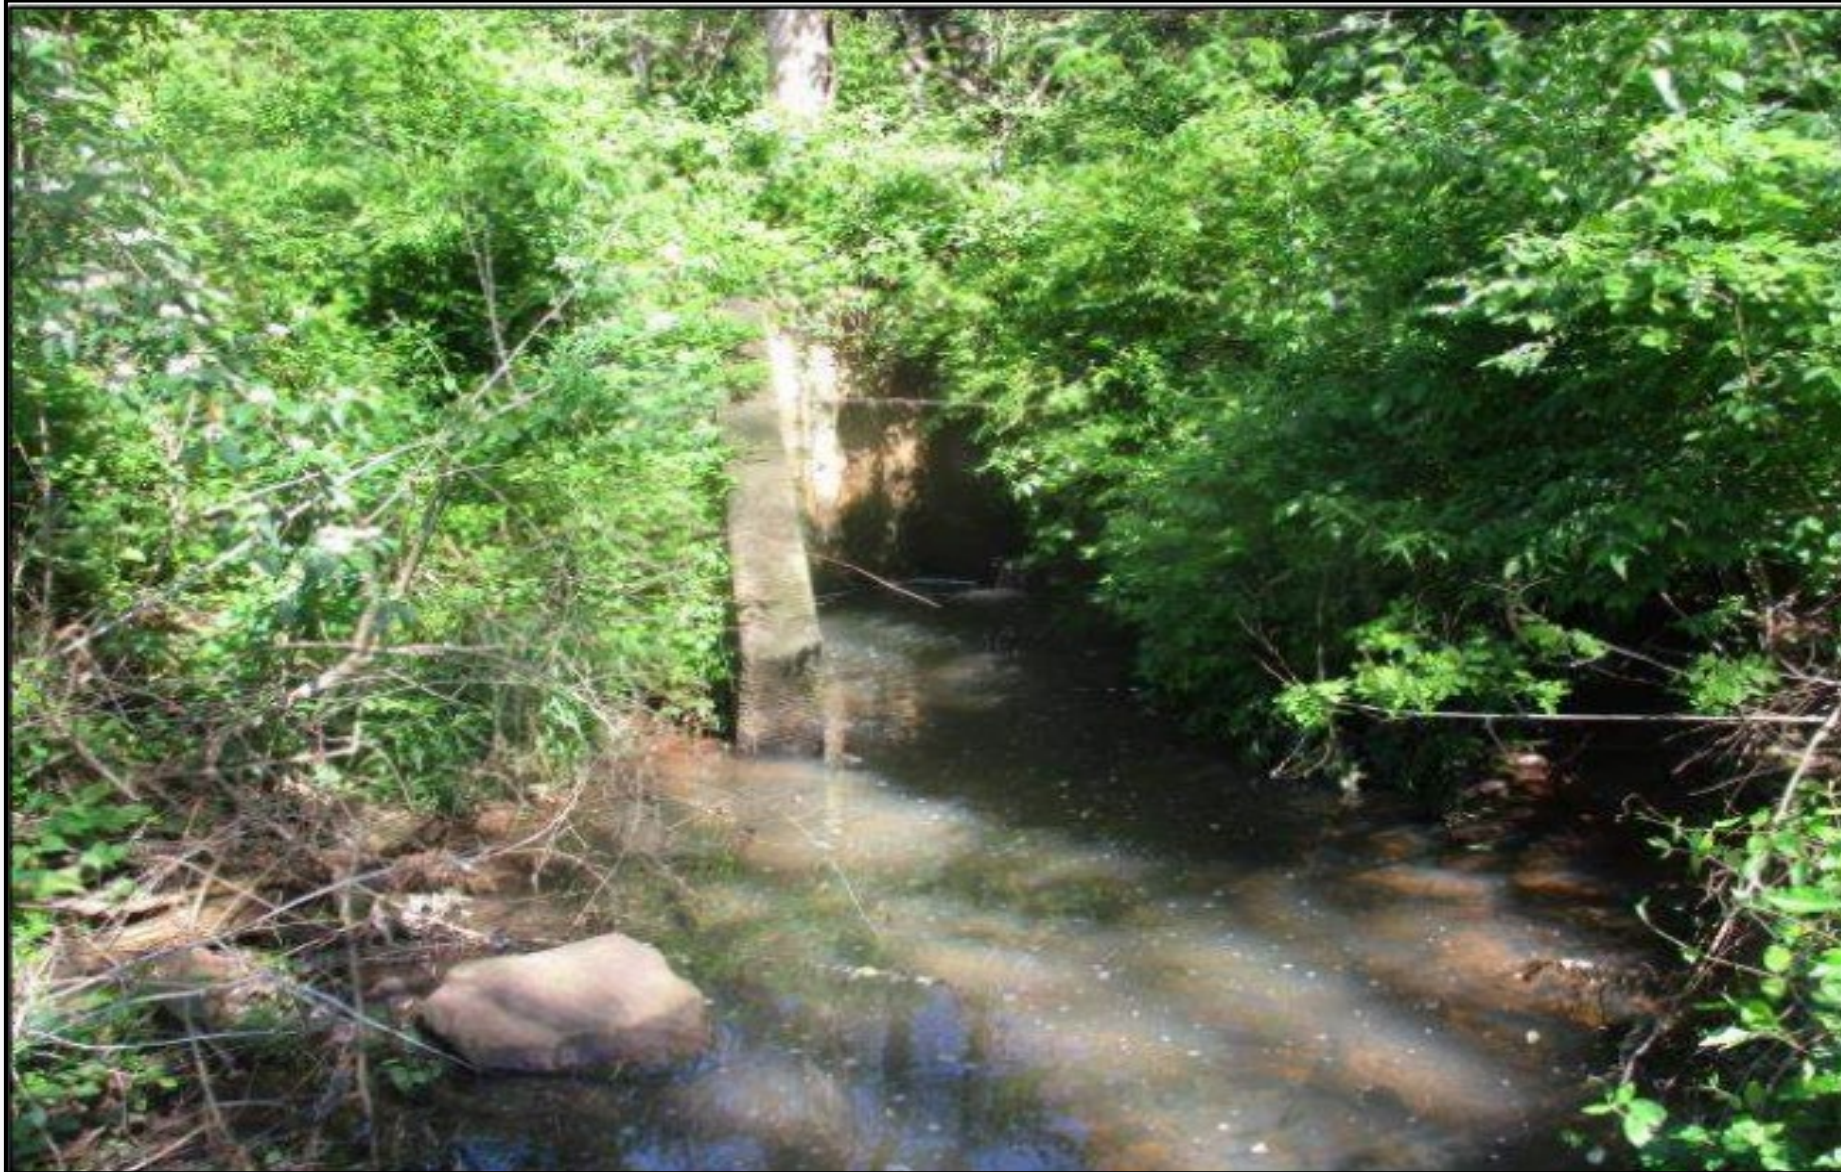
Storm sewer realignment required to aid in erosion control.

**4** - Extension and realignment of the storm sewer discharge point away from the toe of the dam.
